Erfaringer fra Hydrogeneksplosjonen i Sandvika juni 2019 Geirmund Vislie, Gexcon AS

ESRA 26.05.20

Fueling Station Incident *Geirmund Vislie – VP Hydrogen Safety*

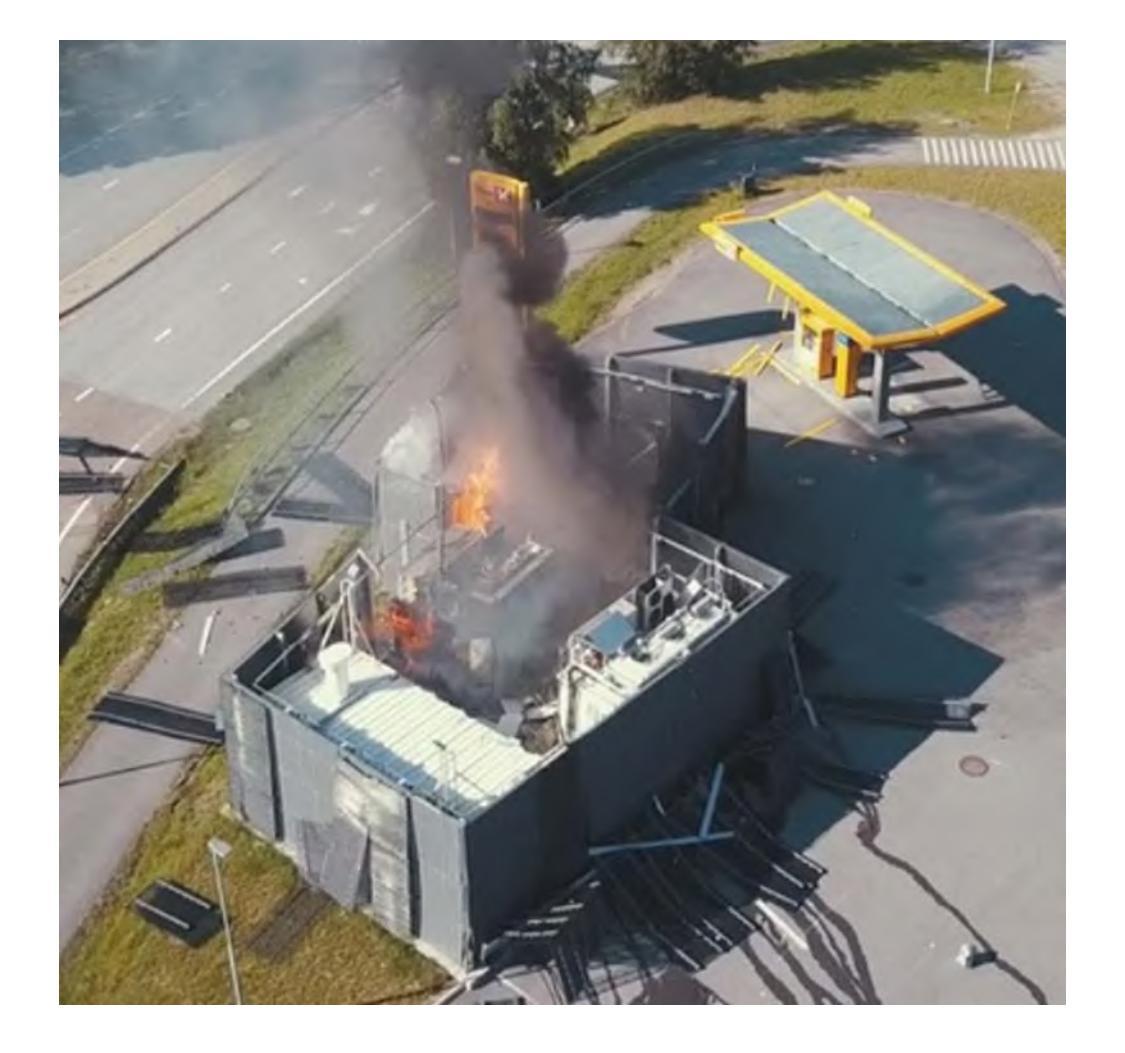
- In the late afternoon of 10 June 2019, a leakage and subsequent explosion occurred at the Hydrogen Fueling Station located in Sandvika near Oslo, Norway.
- The explosion was followed by several fires within the facility.
- Gexcon was called to investigate the root cause of the incident and to propose mitigating measures for implementation in existing and future facilities.

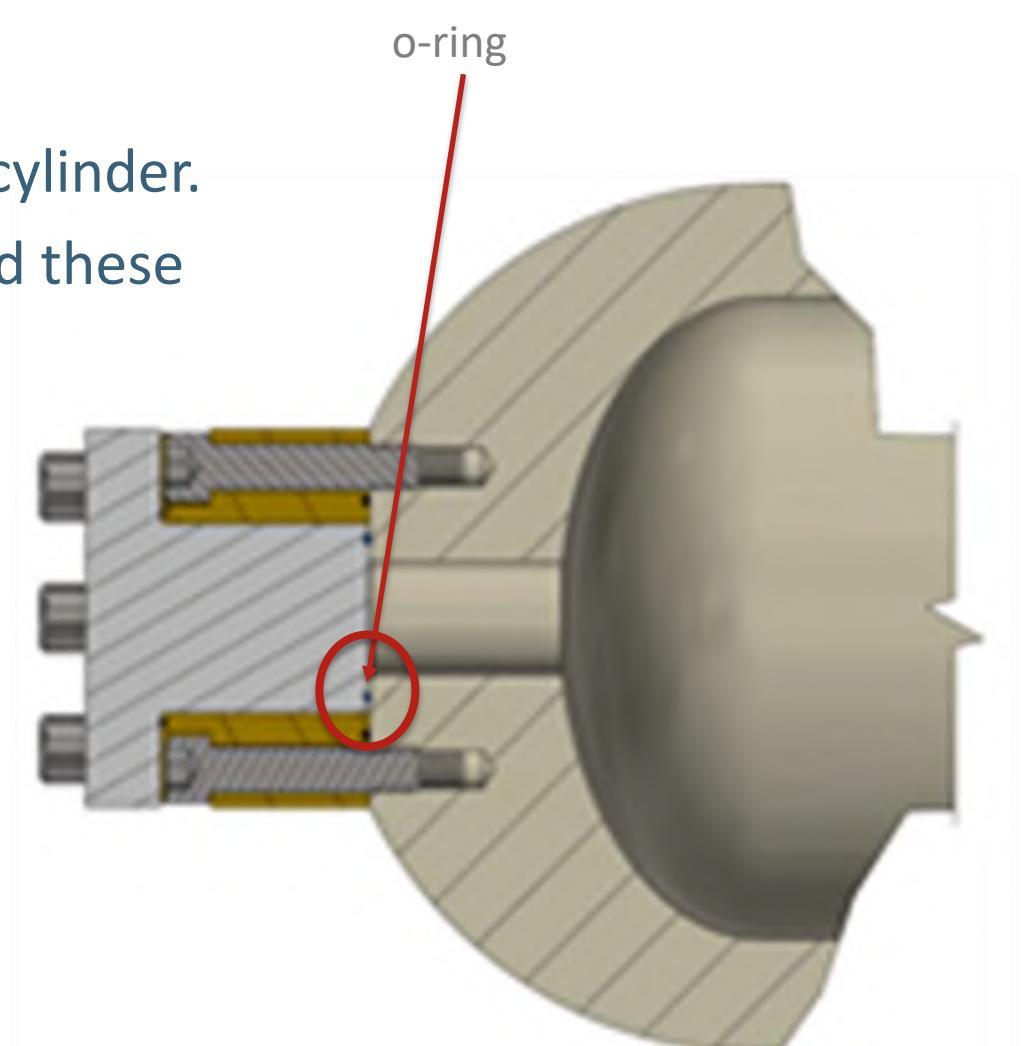
Root cause identified

- Under-torqued bolts in the plug assembly at the end of the cylinder.
- Significant effort was made to explore other possibilities, and these mechanisms were ruled out.
- The leakage started small and developed over time, possibly due to the following mechanism;
 - Insufficient bolt torque
 - Insufficient compression of o-ring
 - Motion of o-ring under pressure cycles
 - Friction/wear
 - Initial, small damage to o-ring
 - Developed to complete failure of o-ring

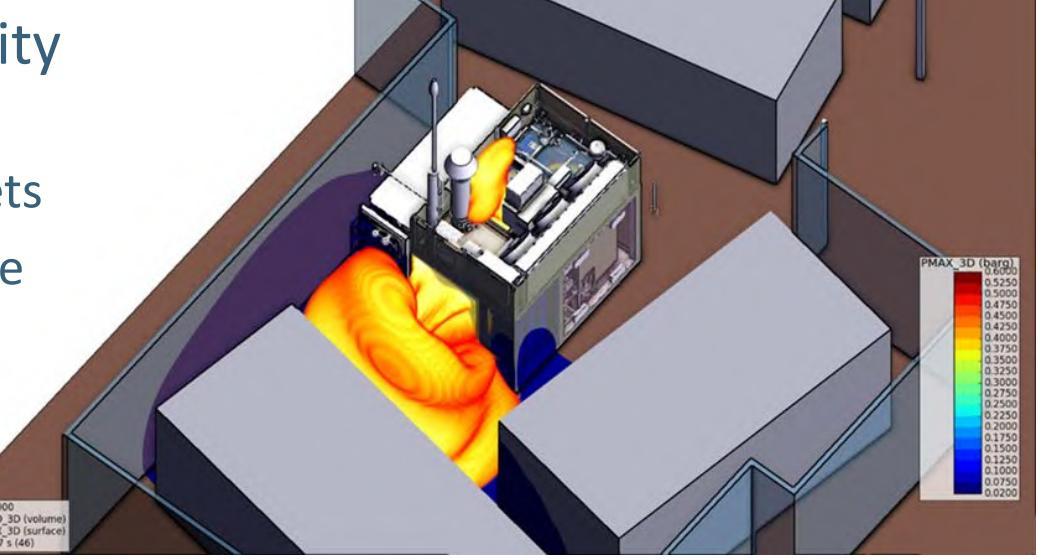
Explosion

- Gas from the leakage dispersed to several parts of the facility
 - Via cable trenches to adjacent modules, such as the electrolyser and auxiliary module, containing switchboards and control cabinets
 - Into compressor module located adjacent to high-pressure storage
 - Free dispersion in air
- Upon ignition, the hydrogen cloud exploded
 - In free air, causing pressure waves affecting traffic on nearby roadway and minor damage to neighbouring building.
 - This explosion also caused flexing of the perimeter wall, causing architectural elements on the external face of the wall to be thrown off.
 - Internal to the compressor module, causing extensive damage. The image is a view of a simulation used to determine the likely amount of hydrogen involved in the explosion within the module.

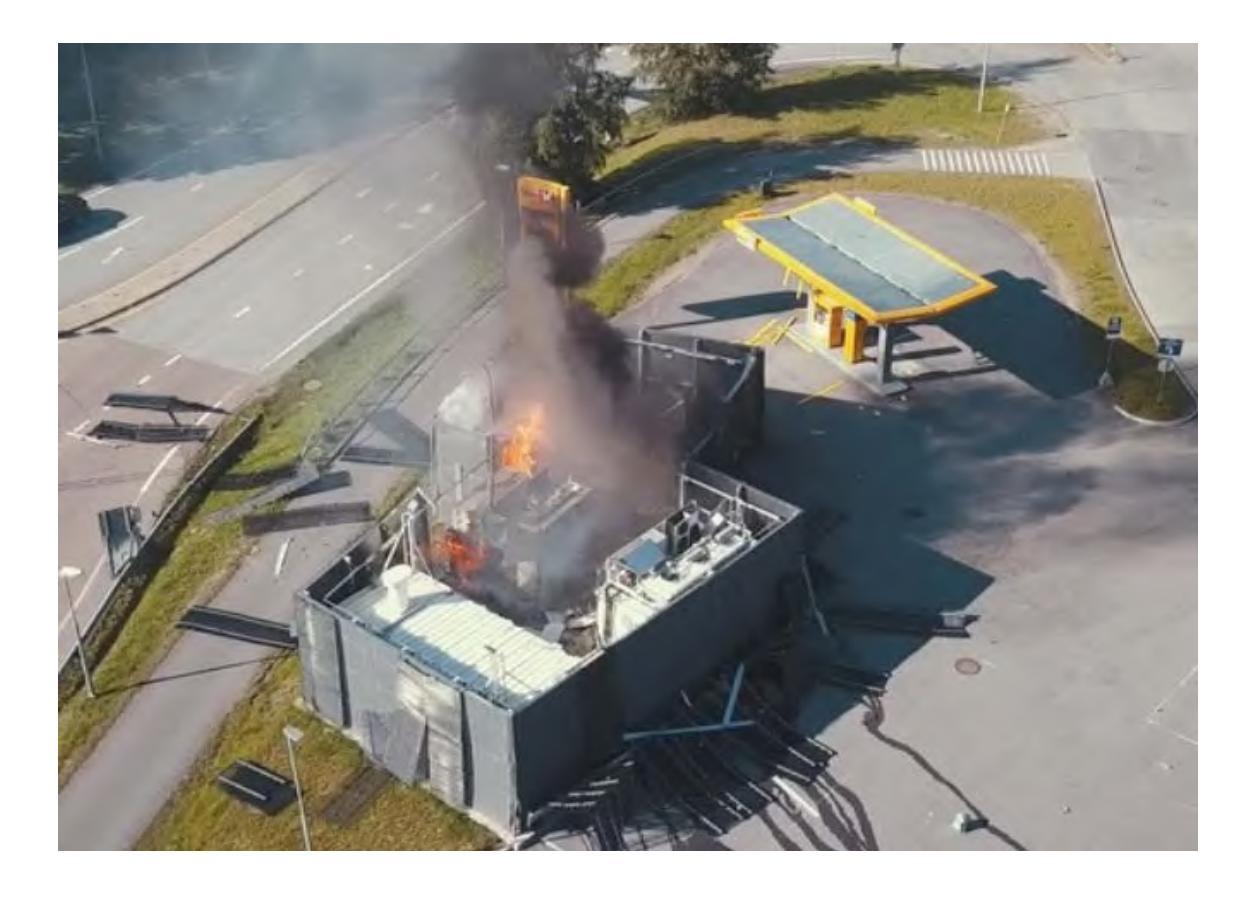
Ensuing fires

- Subsequent to the explosion, several fires occurred
 - Internal to the high-pressure storage, the initial leakage continued as a fire
 - Evidence indicates the explosion caused a new leakage in the high-pressure storage, resulting in a jet fire directed towards the mobile storage container, eventually causing the inner lining of the composite tanks to melt and the stored hydrogen to permeate the composite material and burn off. The burning polyester is the source of the smoke seen in the picture
 - The vent system for the high-pressure storage was destroyed by the internal explosion in the compressor module. When pressure relief valves opened, the hydrogen was fed into a fire internal to the compressor module rather than to the vent mast

- Documented and verified mechanical completion
- Wide use of ATEX rated equipment throughout the facility
- Smart control system algorithms to detect developing failures
- Redesign vent system to reduce vulnerability
- Fire partitions are effective. Should be applied between different storages to prevent escalation
- Fail close valves in the facility had aluminium actuator housings which melted in the fires. Steel housings should be used for improved fire resistance
- Use hard surfaces (e.g. concrete) under all pressurised equipment
- Fill cable trenches with sand or other aggregate to prevent gas migration and possible escalation of incidents
- Improve explosion relief in the compressor module
- Consider to pre-install fire water headers (dry sprinklers) so that responders can connect to single coupling to provide water cooling to all parts of facility in the event of a fire
