# RNNP

## TRENDS IN RISK LEVEL IN THE PETROLEUM ACTIVITY Risikonivå i norsk petroleumsvirksomhet 2016

PETROLEUMSTILSYNET

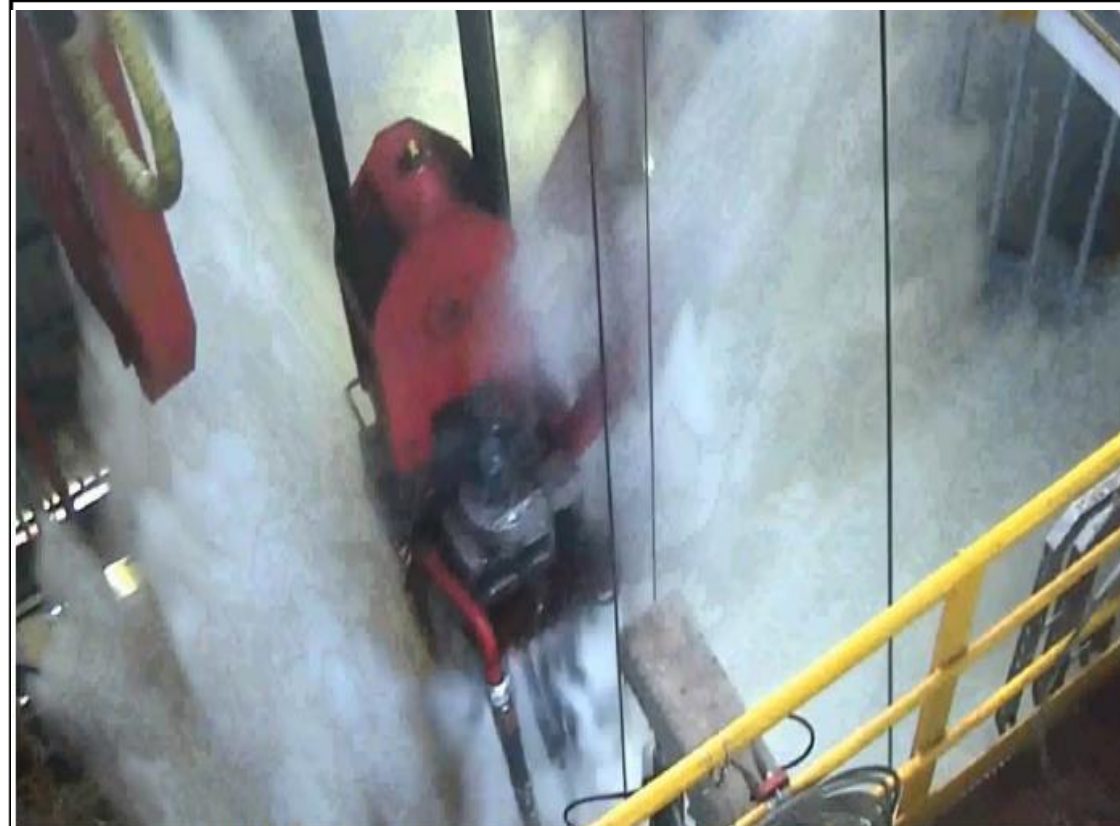
Figur 15 Utstrømning av gass og væske fra fingerbord nivå (kilde: Songa Offshore)

- Incident occurred 15.10 at 09.34, when connecting Pulling Tool to TH with annular BOP open: TH was unlocked and string jumped 5 - 6 m due to HC gas trapped below. Seawater in marine riser evacuated to the rig floor, followed by gas.
- Closed Annular Preventer and Blind Shear Ram. BSR closed on TH and did not shear string.
- Well killed by bullheading, first annulus side and then tubing side after cut and pull TH

- The investigation concluded that FCV's and GLV unintentionally opened during BOP connector pressure test. Poppet valves on top of the TH were exposed during connector test, and pressure was transmitted down the control lines, cycling FCV's and GLV to 100% open position. As a consequence, gas from the reservoir migrated into the well and was trapped below TH and shallow set plug in the tubing until the incident occurred (approximately 6 hours after connector test, see yellow arrows).

- HC gas release on rig floor before BOP was closed. Loss of primary barrier (FCV's and GLV).
- Only one barrier element in BOP (Annular Preventer) available and in function until well was killed (16/10 at 15.00) The BSR and CSR were unavailable due to non-shearable items across these. A procedure to make BSR and CSR available was in place.
- NPT time due to incident is 22,4 days.

- Use deep set plug and not FCV's/GLV as deep set barrier.
- Always check for pressure below shallow plug/TH prior to releasing TH.
- Improve quality in planning and risk management: Identify and emphasize the well specific risks, highlight changes.
- Improve management of change, during planning and execution.

- Need for better understanding of risks associated with the large gas reservoir in Troll
- Improve understanding of Vetco wellhead system by establishing a specific training program for relevant personnel
